Manhole Inspection Summary

Manhole # S33EE_054MH

Insp Date: **2/22/07 9:38 AM**

Location Address: **41 PRESTON ST**

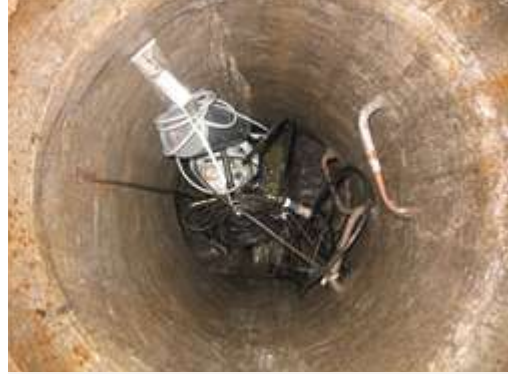
Top View

☒ **Debris** (not Condition related)

☒ **Corroded**

Corroded steps. Bench debris.

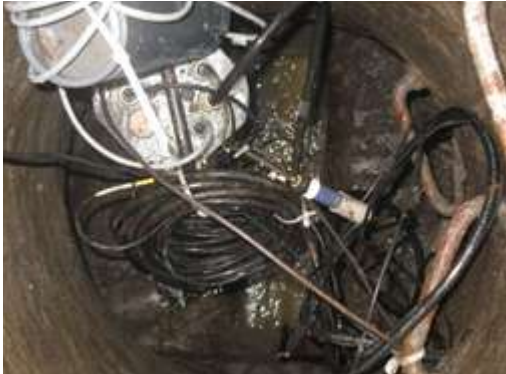
Top View

Corroded steps. Evidence of surcharge - Bench debris.

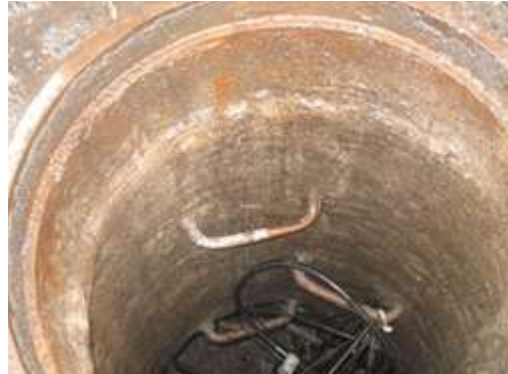
Defect

☒ **Leaks**

Frame leaks.

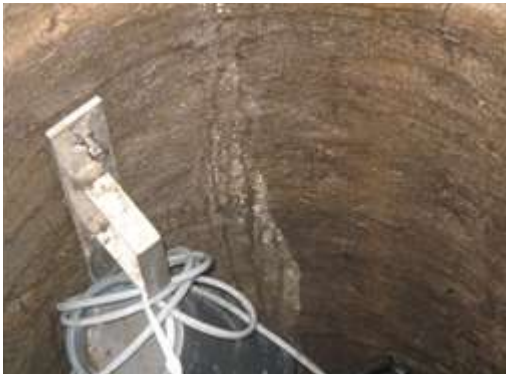
Defect

☒ **Joint**

☒ **Wall**

Adjustment infiltration.

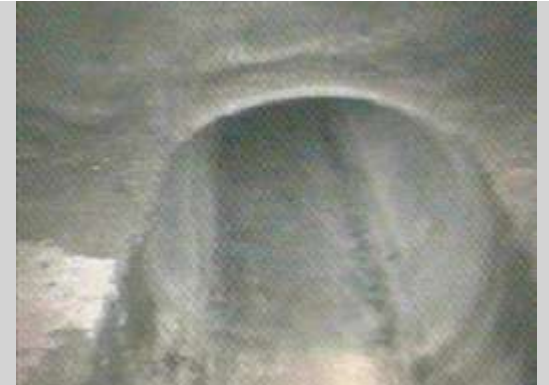
15 in. Circular Gravity Sewer Pipe Out @ 12 O'Clock

Pipe Material: **Unknown** ☒ Pipe Lined

Invert Depth: **11.50** (ft.) Flow Characteristics: **Fast**

Infiltration: **Evidence** Pipe Seal Cond: **Unknown**

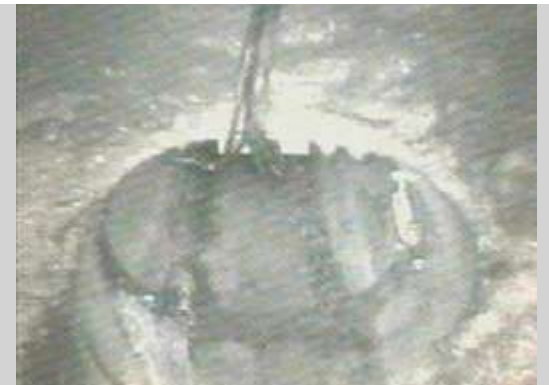
15 in. Circular Gravity Sewer Pipe In @ 6 O'Clock

Pipe Material: **Unknown** ☒ Pipe Lined

Invert Depth: **11.43** (ft.) Flow Characteristics: **Fast**

Infiltration: **Evidence** Pipe Seal Cond: **Unknown**

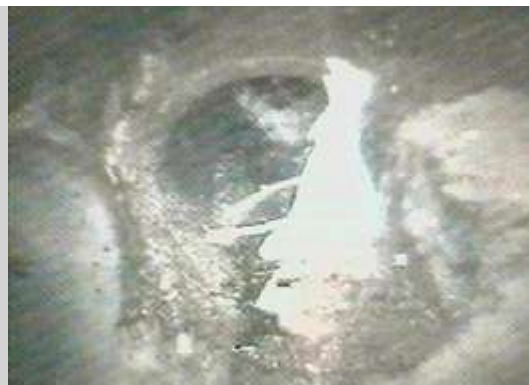
8 in. Circular Gravity Sewer

Deposits: ☐ None ☒ **Mud** ☐ Sludge ☒ **Debris** ☐ Grease

Silt Depth: **3** (in.) Deposits Extent: **Medium**

Infiltration: **Evidence**
